**4-Point Inspection – Personal Lines**  
(Edition 9/2012)

ADDRESS INSPECTED: \_\_\_\_\_

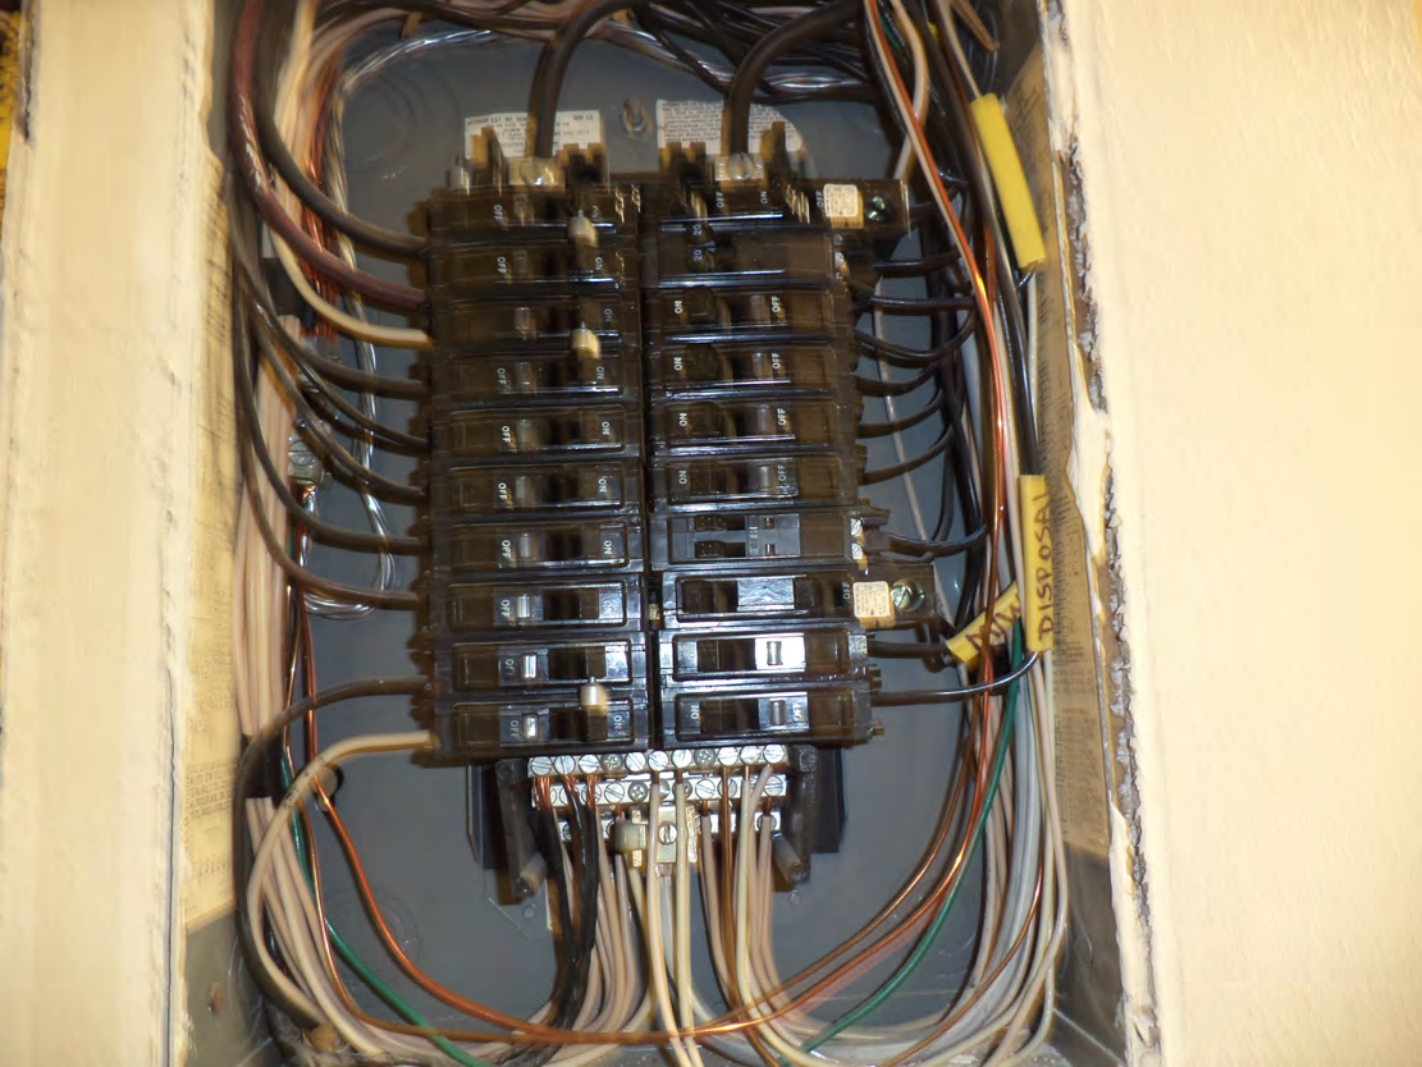
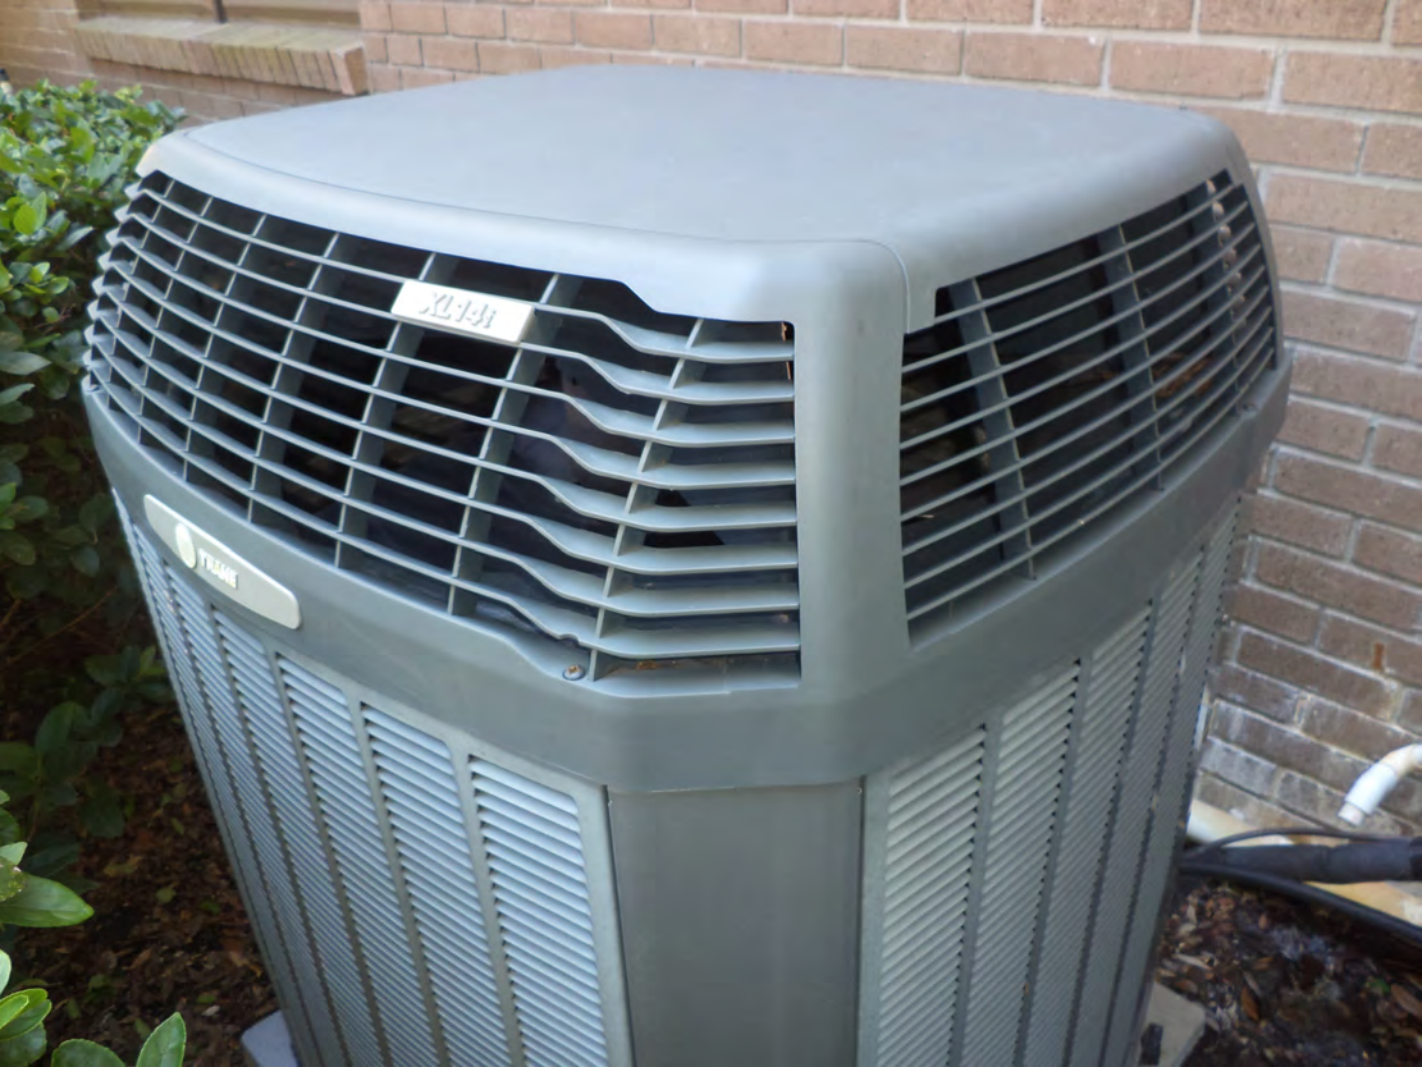
# Fan is down + master
