HOME INSPECTION REPORT

1234 Florida Way USA Fl. 12345
Inspection Date:
March 26 2012

Report Number:
1405

Inspector:
Gary Hatmaker

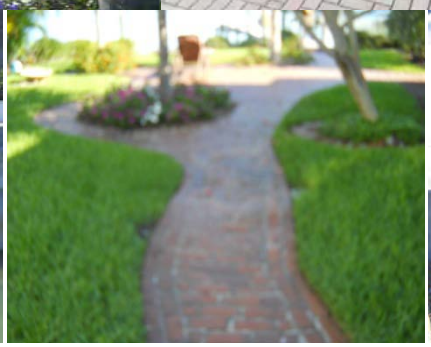
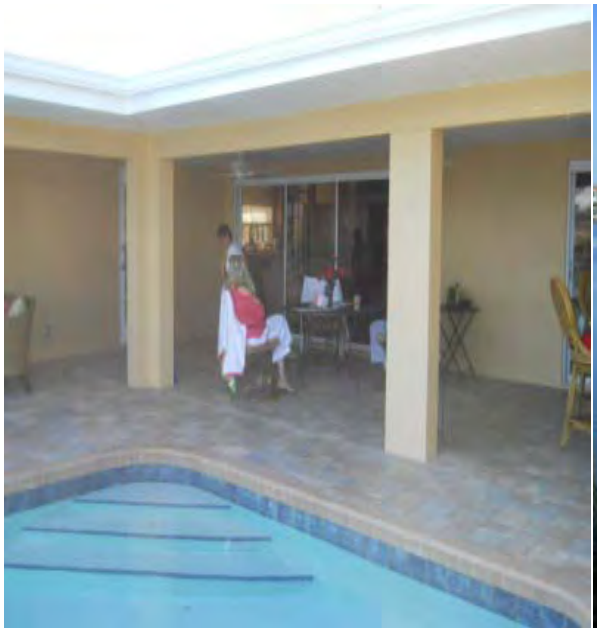
Walkway had some cracking, but is usable. Driveway had some settlement, but usable, repair as needed. Patio had some cracking and settlement, but was in usable condition. Retaining wall at end of patio area had cracked blocks with no new signs of movement

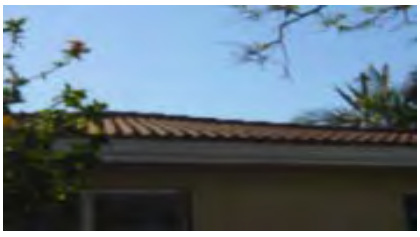
Roof inspection was limited to eaves due to material type. Roof coverings appeared overall satisfactory, but will need minor maintenance. Flat roof over deck has approx. 5 years of life left

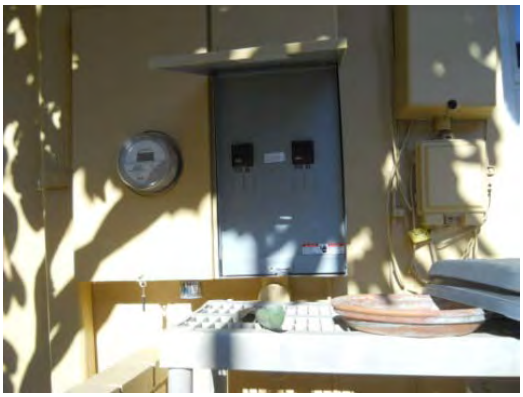
Good operating condition

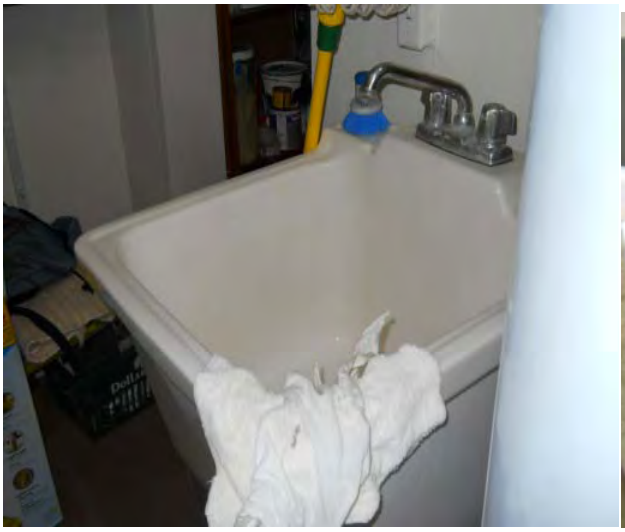
GFCI should be installed across from laundry sink within 6' of water

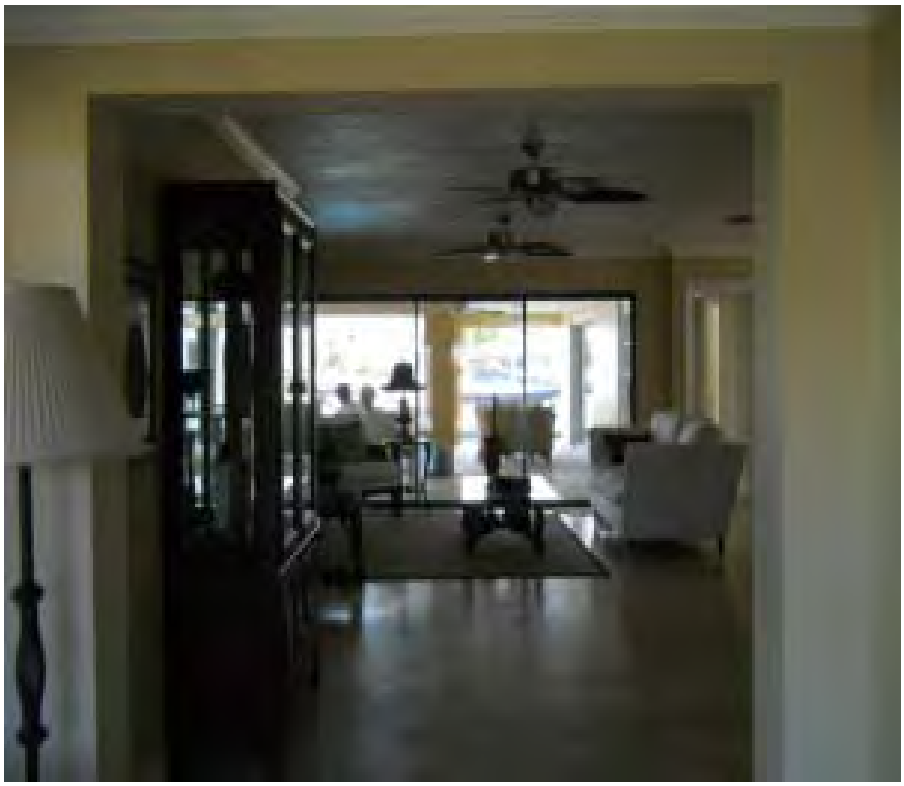
LOCATION: FIRST FLOOR LIVING ROOM | UNIT #

Walls & Ceiling: ☑ Satisfactory ☐ Marginal ☐ Poor ☐ Typical cracks ☐ Damage
Moisture stains: ☐ Yes ☑ No Where:
Floor: ☑ Satisfactory ☐ Marginal ☐ Poor ☐ Squeaks ☐ Slopes
Ceiling Fan: ☐ N/A ☑ Satisfactory ☐ Marginal ☐ Poor
Electrical: **Switches:** ☑ Yes ☐ No **Receptacles:** ☑ Yes ☐ No **Operable:** ☑ Yes ☐ No
Open ground/Reverse polarity: ☑ Yes ☐ No ☑ Safety Hazard ☐ Cover plates missing
Heating Source Present: ☑ Yes ☐ Not visible **Holes:** ☐ Doors ☐ Walls ☐ Ceilings
Egress Restricted: ☑ N/A ☐ Yes ☐ No
Doors & Windows: ☑ Satisfactory ☐ Marginal ☐ Poor ☐ Cracked glass
☐ Evidence of leaking insulated glass ☐ Broken/Missing hardware

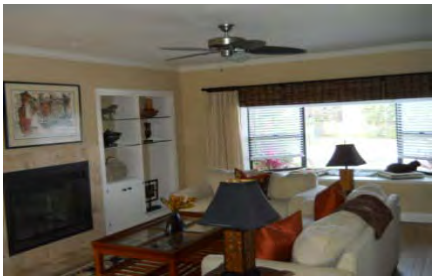
LOCATION: FIRST FLOOR OFFICE ROOM | UNIT #

Outlets had open grounds - Recommend repair as necessary - Safety Concern.

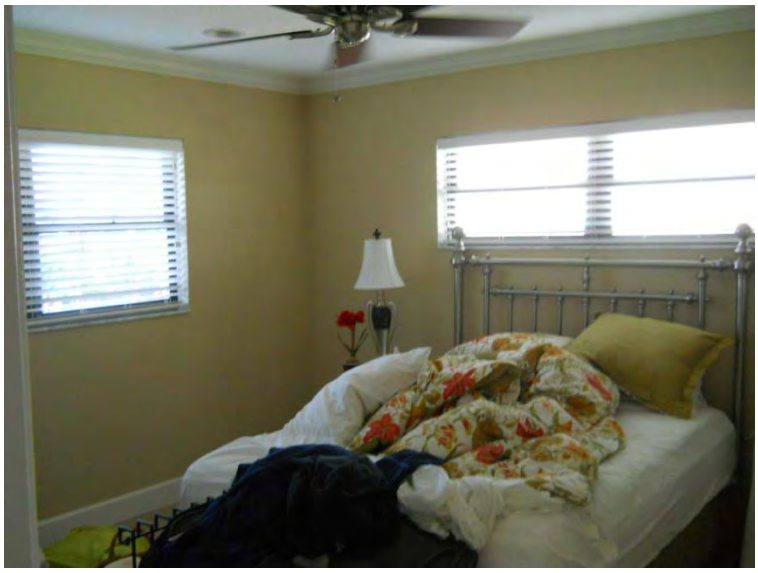
LOCATION: FIRST FLOOR BEDROOM | UNIT #

Walls & Ceiling: ☑ Satisfactory ☐ Marginal ☐ Poor ☐ Typical cracks ☐ Damage
Moisture stains: ☐ Yes ☑ No Where:
Floor: ☑ Satisfactory ☐ Marginal ☐ Poor ☐ Squeaks ☐ Slopes
Ceiling Fan: ☐ N/A ☑ Satisfactory ☐ Marginal ☐ Poor
Electrical: **Switches:** ☑ Yes ☐ No **Receptacles:** ☑ Yes ☐ No **Operable:** ☑ Yes ☐ No
Open ground/Reverse polarity: ☐ Yes ☑ No ☐ Safety Hazard ☐ Cover plates missing
Heating Source Present: ☑ Yes ☐ Not visible **Holes:** ☐ Doors ☐ Walls ☐ Ceilings
Egress Restricted: ☑ N/A ☐ Yes ☐ No
Doors & Windows: ☑ Satisfactory ☐ Marginal ☐ Poor ☐ Cracked glass
